1. REPORT DATE (DD-MM-YYYY) October 2013		2. REPORT TYPE Technical Paper		3. DATES COVERED (From - To) October 2013- December 2013	
4. TITLE AND SUBTITLE FAILURE ANALYSIS OF HIGH PRESSURE TEST FACILITY CONTROL VALVES			5a. CONTRACT NUMBER In-House		
			5b. GRANT NUMBER		
			5c. PROGRAM ELEMENT NUMBER

FAILURE ANALYSIS OF HIGH PRESSURE TEST FACILITY CONTROL VALVES

P. M. Rice, M.S., P.E, M. Heitstuman, B.S.M.E., 1LT, USAF & J. Blanton, B.S.M.E., 2LT, USAF
Air Force Research Laboratory, Aerospace Systems Directorate, Rocket Propulsion Division
Edwards AFB, CA

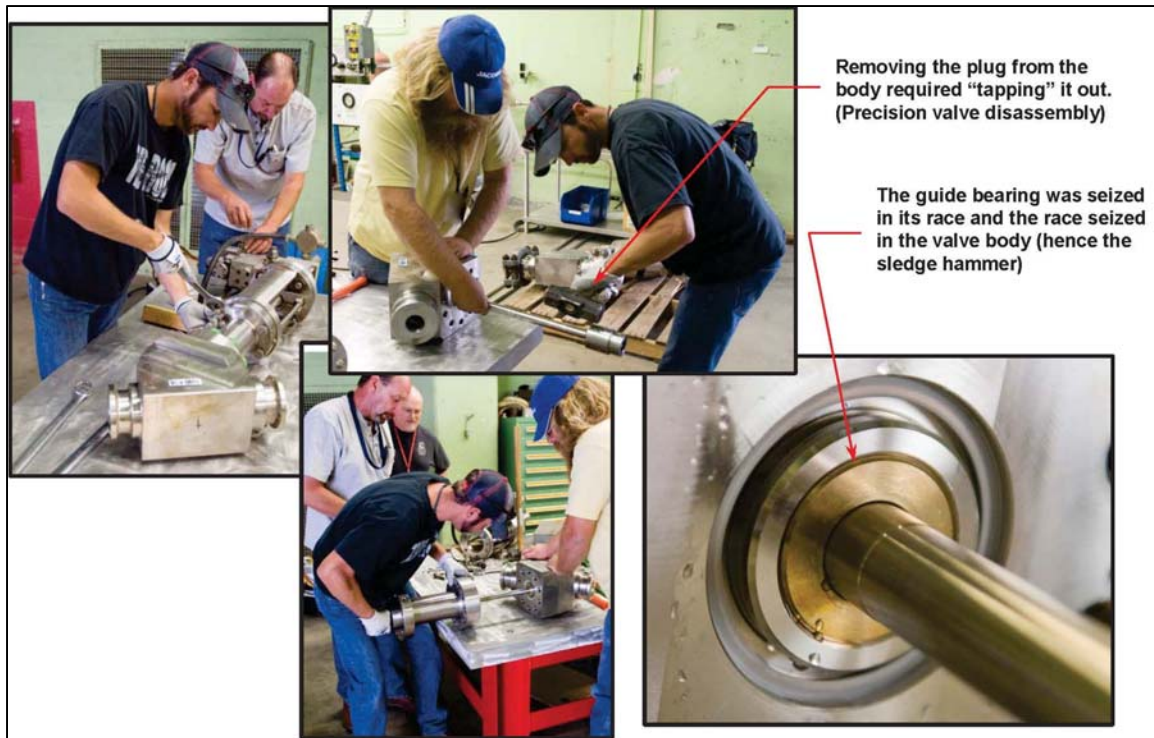
Figure 3. Removing the plug from the valve body was very difficult. We would not usually use a sledge hammer to get the plug/stem assembly out of the valve.

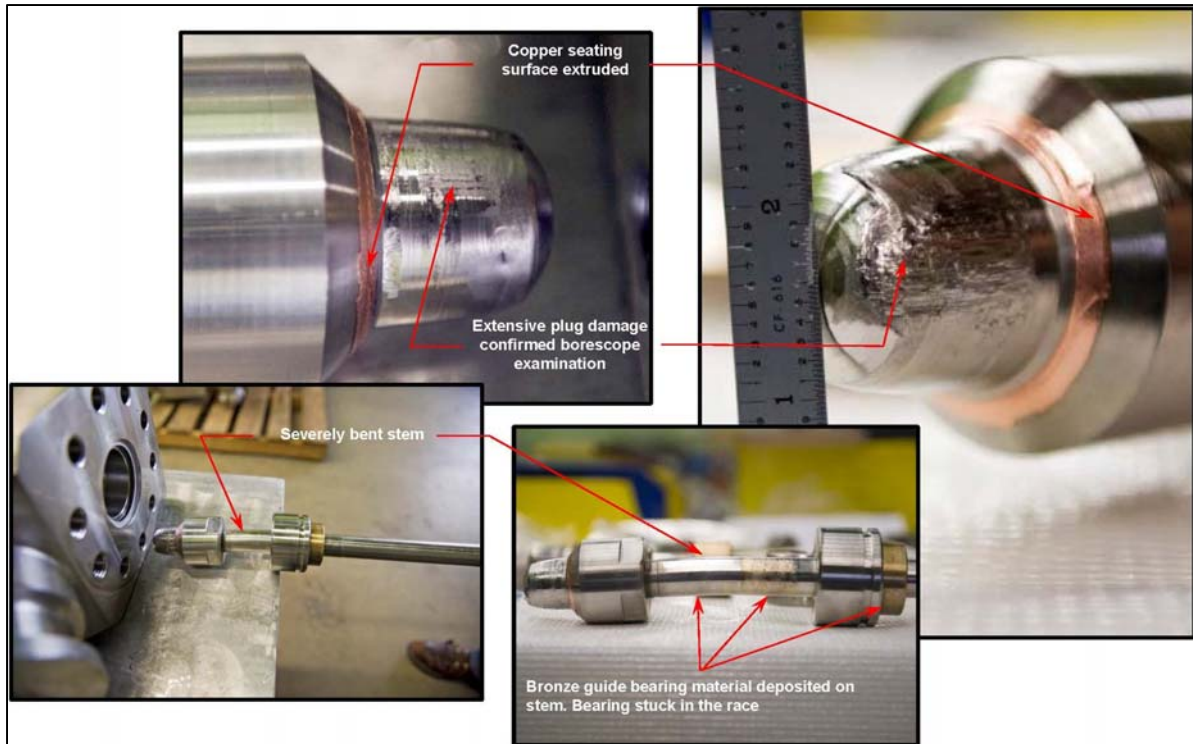
Figure 4. Extensive damage to the plug and stem was found. The stainless steel on the plug had been scraped off in the area where the plug crashed into the valve body seat. The copper seat on the plug was badly damaged and the stem was severely bent. We also found that the bronze guide bearing had rubbed so hard on the stem once it bent, that the bronze was deposited onto the stem itself.

Upon examination of the disassembled hardware, the failure was identified as a bent stem. At this point, we were faced with determining what could have caused the stem to bend. There are only two modes by which the stem could have bent in the manner it did: buckling and/or a cantilever load placing a bending moment on the stem. Now, intuitively based on the evidence, we thought that the stem bending could only have occurred due to a bending load; however, we have clearly demonstrated on other valves (much to our embarrassment) that it is entirely possible to buckle the stem by over-adjusting the stem projection into the valve seat and then applying an excessive load from the actuator. In the past, we have only seen this happen on very small valves (less than $\frac{3}{4}$ inch), where the l/d ratio is high. Unfortunately, there is no clear line of demarcation in regards to l/d ratio that distinguishes when buckling would occur that can assist us in making this determination. However, based on our experience, valves sized $\frac{3}{4}$ inch and up are not as prone to stem buckling. Valves the size of XCV-0010 and 2010 are highly unlikely to fail in this manner. Additionally, the bending that occurred was inconsistent with the manner in which a column with both ends fixed would bend, lending further evidence to our claim. Thus, we decided to start our analysis by building a model in SolidWorks and performing a finite element stress analysis. A cantilever load was placed on the stem to simulate the upstream pressure experienced during valve actuation.

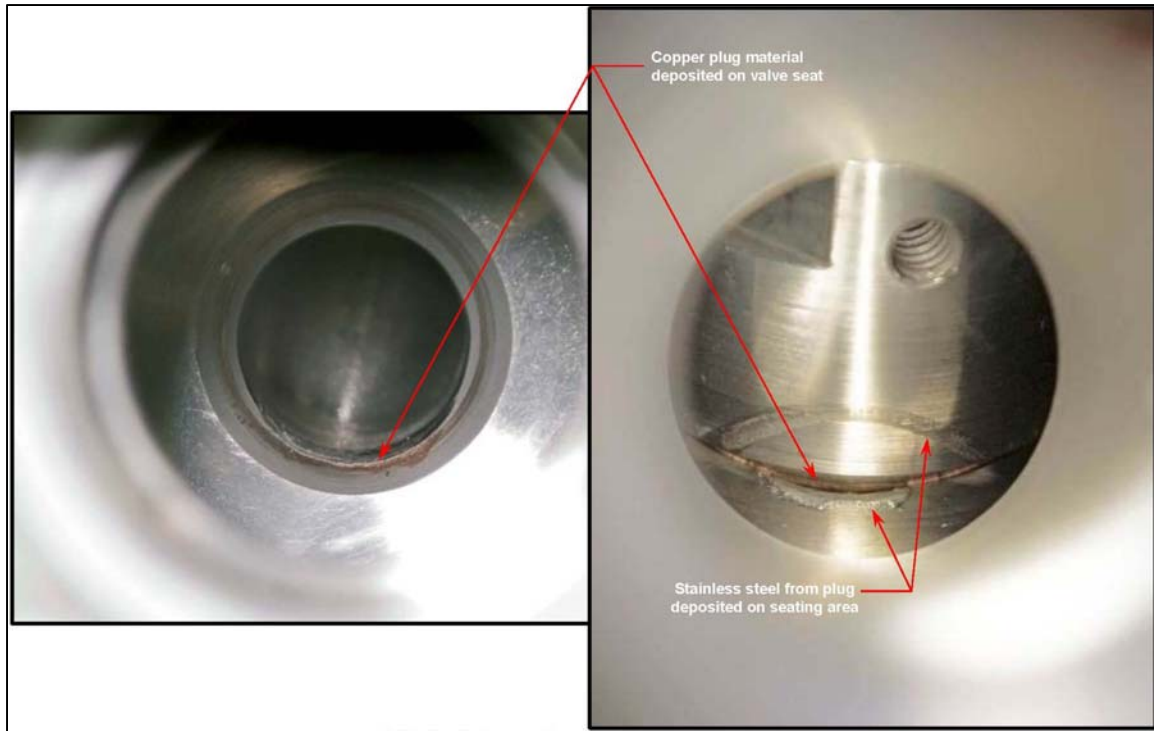
Figure 5. What you are looking at is the seating area of the valve body. Note that stainless steel in the seating area has been scrapped so hard that the plug contact area has rolled over where the plug contacted. Also, you can see where we found copper from the valve plug deposited on the valve seat.

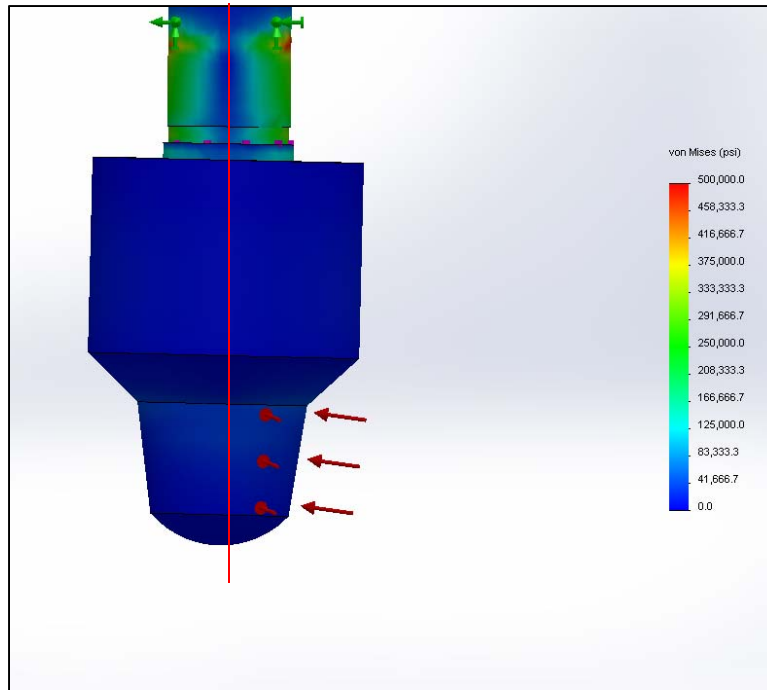
We constructed the models based on these constraints and assumptions in SolidWorks, and performed a series of finite element analysis studies. FEA studies were performed for both bending and buckling. The valve failed in bending by a large margin consistent with the postmortem examination of the valve. The analysis indicated that the factor of safety (FOS) in buckling was 8 (which means, the load required to make the stem fail is eight times larger than the axial load applied to the stem by the actuator in the closed valve position), so we decided that no further buckling analysis was warranted. The results are presented in and discussed with **Figures 6, 7, and 8**.

Figure 6. This graphic shows the output of the finite element solver displaying the maximum von Mises stress for the XCV-0010 stem/plug. Notice, as we stated in our assumptions, that the force of the pressure was placed orthogonal to the face of the plug, but to be conservative, only applied to the projection of the plug tip and not the whole wetted area of the plug (the large diameter portion). The results show that the maximum stress on the stem (487 ksi) occurs at the location of the cantilever support (guide bearing), and greatly exceeds the yield strength of the stem, resulting in permanent deformation. If you look carefully at the centerline, you will also notice slight bending of the stem. This is less than the real stem, but shows that even with this very conservative analysis, the stem would bend. If the maximum stress had not exceeded the material allowable, you would only see displacement on a greatly exaggerated (50x or greater) graphic (see next figure).

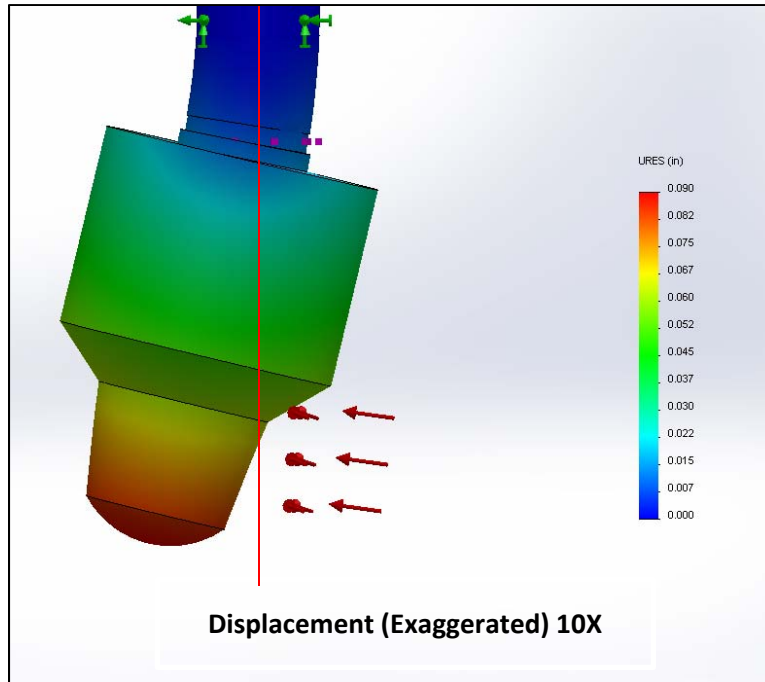
Figure 7. Seen here is the displacement exaggerated by 10 times to show the bending of the stem beginning at the location of the lower guide bearing. The maximum displacement according to the conservative model is approximately 0.09 inches. It doesn't seem like much, but permanent deformation of the stem on this magnitude indicates both an extreme overload, and in this case, certain interference between the plug and the valve seat.

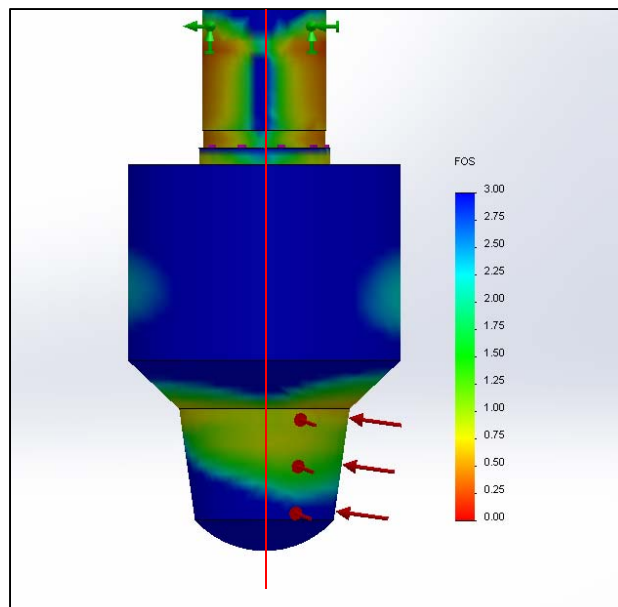
Figure 8. Here you can see the results of the finite element solver displaying the FOS for the XCV-0010 stem/plug. The results show that the FOS was less than one (1) in many areas of the structure with the minimum being 0.21. This means that permanent deformation occurred. No displacement is shown in this particular graphic.

The cause of the failure appears to be purely mechanical as there were no control system or operation errors that could be traced to the valve failures. Several obvious design flaws in the valve are considered to be major contributors to the failure of the valve. First, the large surface area projection of the plug into the flow stream subjects the stem and plug to an excessive load. Second, the distance from the stem guide bearing to the plug creates a long cantilever arm that promotes bending of the stem. This feature is not typical of other high pressure valves, which have guide bearings located much closer to the plug and have proven reliable in similar/identical environments. Third, the stem guide bearing tolerance was such that the stem was not well supported by the bearing, thus lending opportunity to produce greater displacements and higher stress concentrations on the valve stem. Finally, the ratio of the stem diameter to the plug diameter ($d_{\text{stem}}/d_{\text{plug}}$) is low. This feature creates a higher stress concentration at the stem-plug interface.

To prevent this from occurring again in the as-built system, we found the location of all the installed valves that have a similar design by the same manufacturer. There were two additional valves identified on the installed system, and one installed on the test skid for the HCB program. We took the following steps to determine the extent of the problem and mitigate the program impact:

1. We verified the service requirements for each valve in order to determine whether they were susceptible to a similar type of failure.

2. We removed and replaced “high risk” valves where possible and tagged those valves to identify that they are not approved for future use in similar high-pressure applications.
3. We located out-of-service valves of the same design and identified them for non-use pending an engineering evaluation for proposed future service.

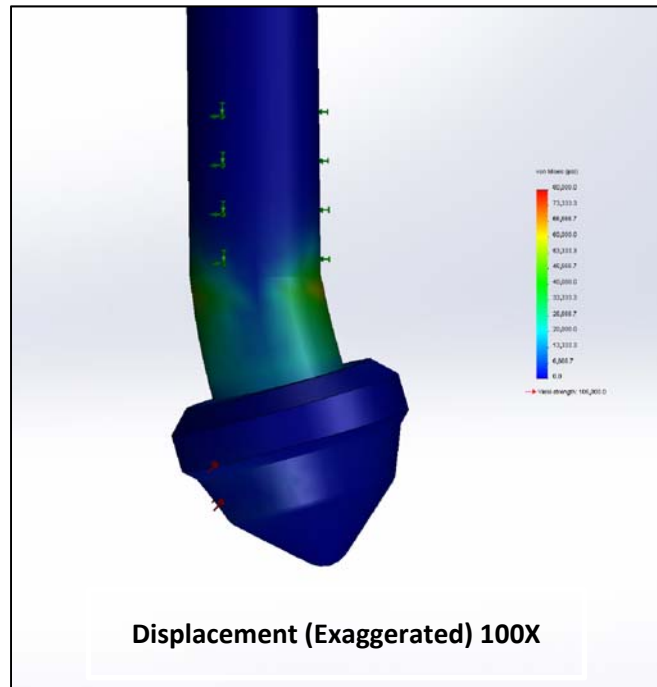
Figure 9. This graphic shows the output of the finite element solver displaying the maximum von Mises stress for the XCV-3003 stem/plug. Notice, as we stated in our assumptions, that the force of the pressure was placed orthogonal to the face of the plug, however in this less conservative case, applied to the whole projection of the plug tip. The results show that the maximum stress on the stem occurs at the location of the cantilever support (guide bearing), but in the case of this valve, the stress does not exceed the yield strength of the material. Note that the deflection in this graphic is exaggerated by 100 times. Otherwise, as in **Figure 6**, it is undetectable.

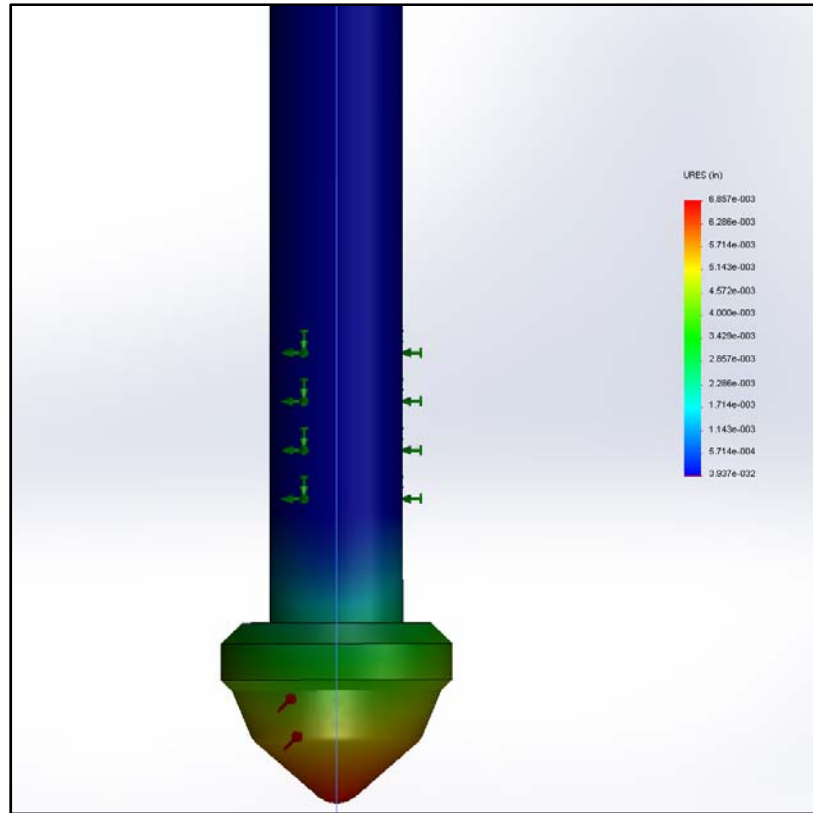
Figure 10. Seen here is the displacement results showing the maximum displacement is at least an order of magnitude less than XCV-0010, and would return to zero once the load is removed since no permanent yielding took place.

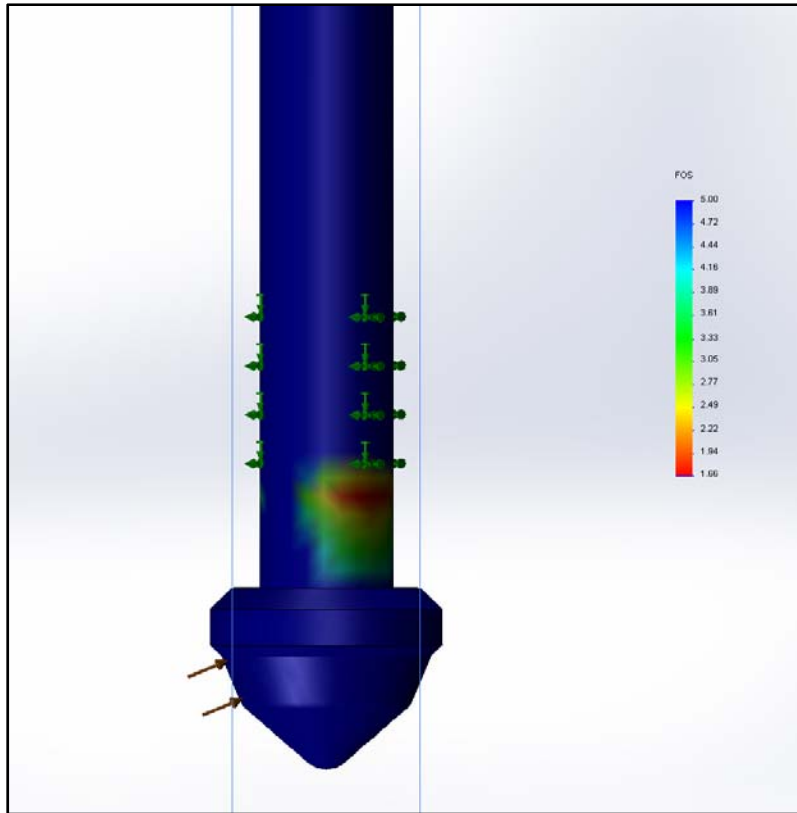
Figure 11. Here you can see the results of the finite element solver displaying the FOS for the XCV-3003 stem/plug. The results show that the FOS was greater than one (1) in all areas of the structure with the minimum being 1.60. This means that the FEA indicated no permanent yielding of the stem.
